2007-2013 **Chevrolet Silverado/GMC Sierra**

Possible Washer Nozzle Interference that may affect other aftermarket wiper blade products - NOT ClearPlus.

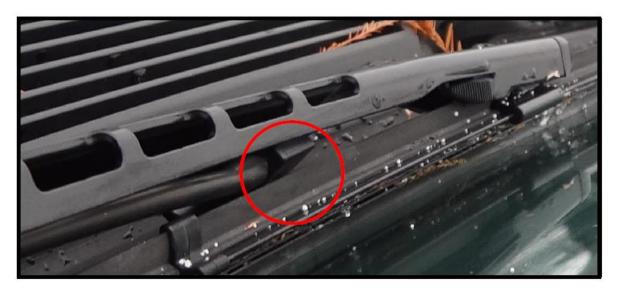
Both the Chevrolet Silverado and the GMC Sierra have a washer nozzle located beneath the wiper arms of both the driver side and passenger sides. Further investigation found that the clearance between the OE blade and the washer is minimal.

The original blade is 16.5mm high (.65 in.), measured from the bottom of the squeegee to the tip of the spoiler. The OE spoiler is located off-center to the rear of the wiper blade. Some aftermarket blades are of varying height and many have the spoiler down the middle of the blade. The different height and location vs. the OE blade may allow the spoiler to press against the washer nozzle affecting wipe quality.

ClearPlus wiper blades will not have this problem.
